## **River Cale, Wincanton**

**An Advisory Visit by the Wild Trout Trust February 2013**

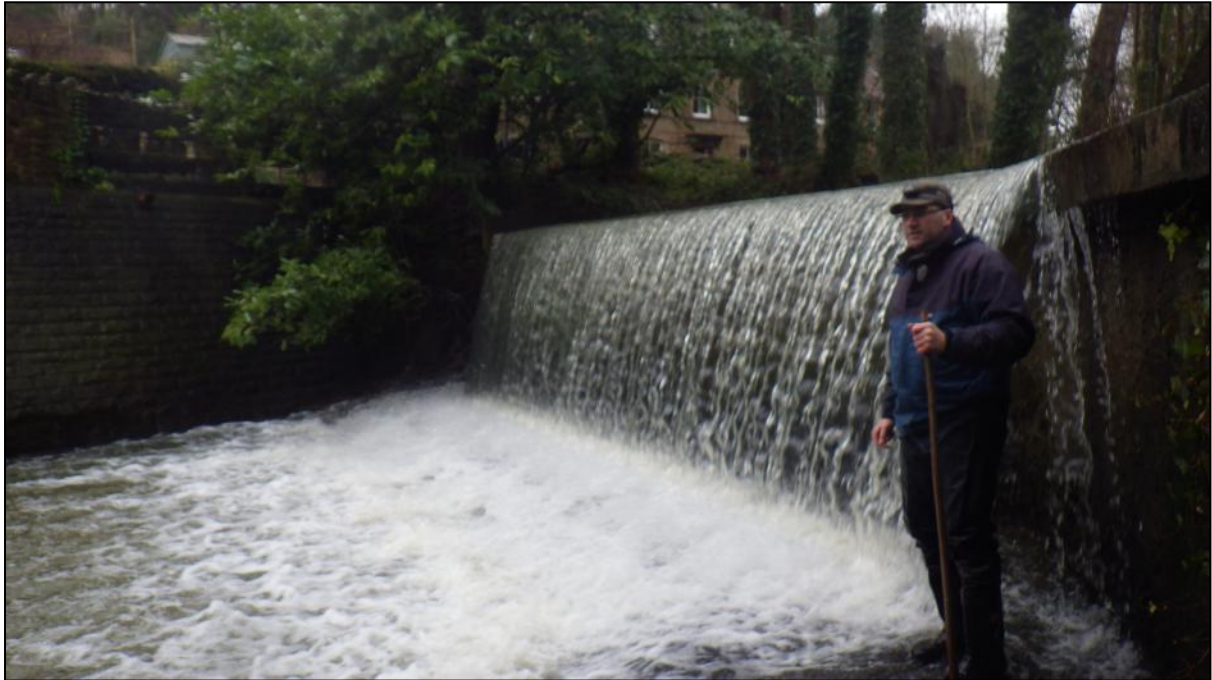
At ST 71103 28896, a large weir, known locally as *The Waterfall*, is a complete barrier to fish passage and fragments the river habitat. Fish populations above the structure are completely isolated and vulnerable to pollution events, being unable to naturally recover by means of recruitment from fish downstream. In order for the River Cale to function as a fully connected habitat, the weir should be removed. Such an action however, may be unfeasible in the short to medium term. The Waterfall is a prominent feature and a significant landmark in the town. It is highly likely that local residents would resist plans to remove or significantly alter the structure. In addition, the size of the impoundment means

**Figure 2: The 'waterfall' is a straight-drop, wide crested weir that completely fragments the river habitat and cuts the headwaters of the river off from the river downstream.**

that removal of the weir would require significant re-profiling of the river for a considerable distance upstream.

In the short-medium term, actions to improve the Cale should remain focussed on the river downstream.

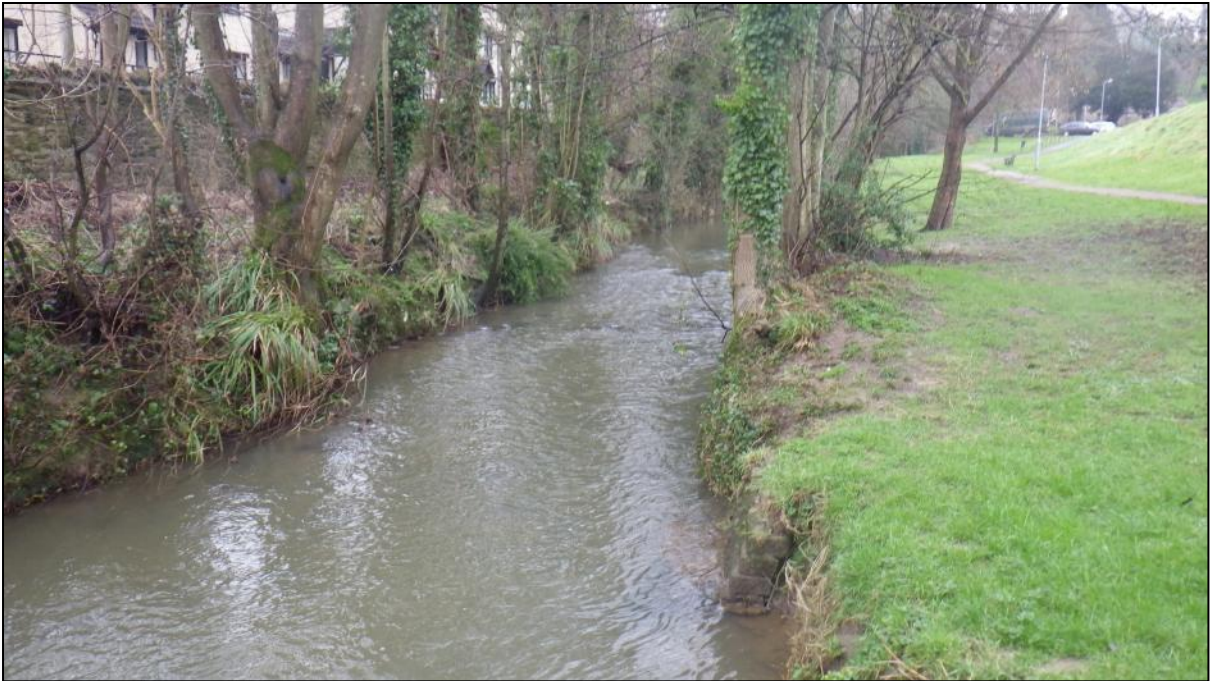
However, too much shade can limit the growth of river plants and can deprive the river ecosystem of its main primary production, significantly impacting the food web of the river. A roughly 50:50 ratio of direct sunlight to dappled shade is recommended in order to ensure that rivers are kept cool whilst also allowing aquatic and emergent plants to establish.

**Figure 3: Some sections may be slightly over-shaded in mid-summer when bankside trees are fully in leaf.**

The recreational importance of this stretch of the river may make it a good candidate for a habitat project. Tree works to punch occasional 'skylights' in the tree canopy or thin out some of the smaller trees amongst the bigger ones could benefit river plants and the wood arising from such works could be used to create some simple woody debris habitat features in the channel.

It may also be beneficial to introduce greater variation in the heights and densities of the crowns of the trees so that the variation in light conditions is more easily maintained.

4. Once volunteers have built their confidence, a well-publicised project at The Beach could help to significantly raise awareness of the river. Tree works to allow a little more light into the river would also provide material that could be fixed to the bed to create LWD habitat features and flow deflectors. Tree works may have an associated cost and a project here may be more likely to attract local funding if other projects have been already installed nearby to demonstrate the benefits.

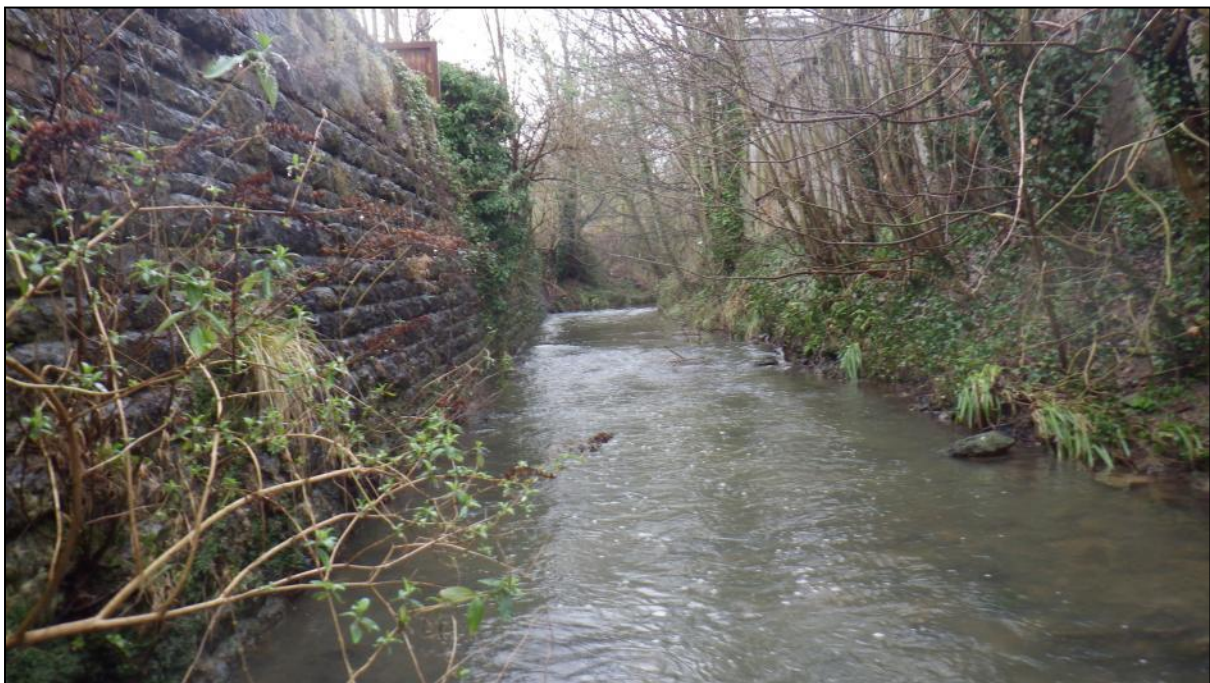
Immediately downstream of this section of the Cale, the river suddenly becomes much less accessible and is straightened and canalised between a wall and a steep bank. The channel is wide and as a result the water level is relatively shallow. The modified channel has created a uniform habitat lacking in features for flow-loving fish.

**Figure 4: The straightened, canalised section of the river could be cost-effectively improved by repositioning existing bed load**

Habitat improvement works could be undertaken relatively easily and cost-effectively. The bed is littered with large cobbles and blocks which could be very easily repositioned to introduce greater physical diversity. Flows could be deflected to create pockets of increased bed scour and greater variation in velocity. In addition, more light could be let into the channel by trimming some of the overhanging hazel on the left bank (right of Figure 4 below). This could be done by hand with pruning saws.

Works could be undertaken by volunteers at little or no cost potentially making this site a quick-win option for kick starting a wider scheme of habitat works. However, care should be taken to ensure that enough of the habitat currently provided by the large stones for bullhead (*Cottus gobio*), is preserved so as to not harm the resident population. The bullhead is a small fish, sometimes called 'Millers Thumb' because of its unusual shape, which can spend almost its entire life under one stone. They are a protected species, enjoying high-level conservation status and present in the Cale.

3. The straightened section of river downstream of The Beach (Fig 4) could be a good location for another phase of work. Although this section of river is obscured from public view, the habitat could be significantly improved by the labour of volunteers simply repositioning some of the existing large stones into alternating 'D-shaped' berms or simple flow deflectors. This will help to create a more natural flow path through the reach and introduce greater variation of depth and flow velocity.

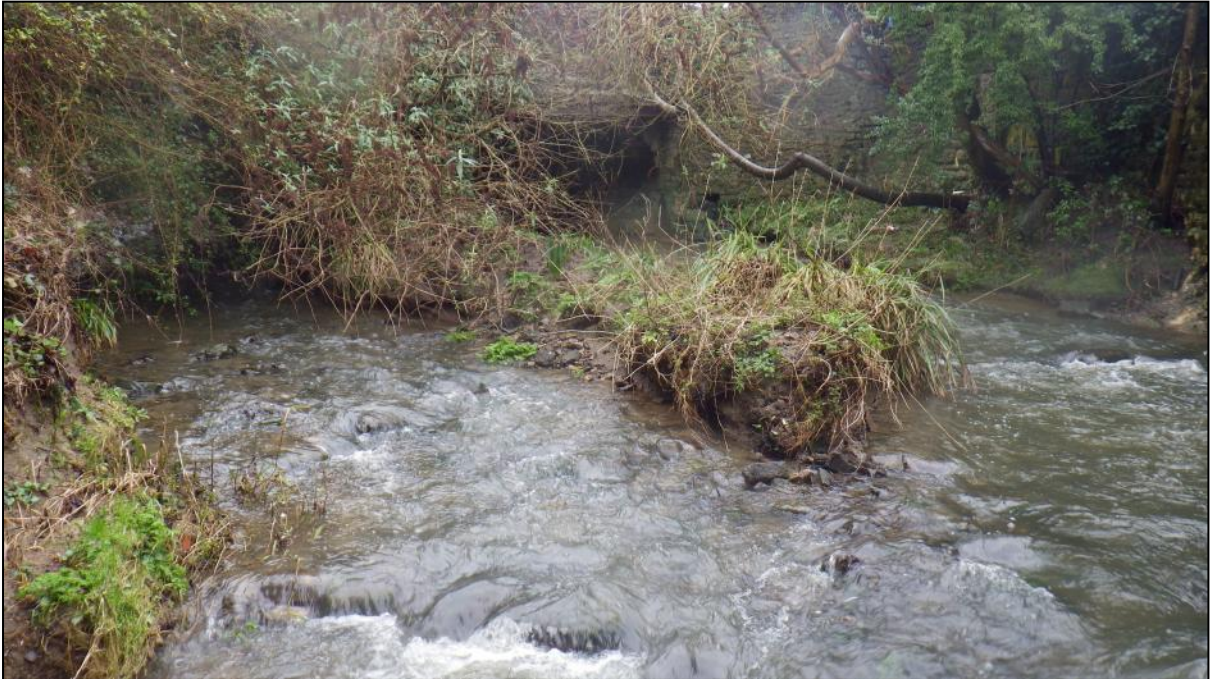
After the straightened section, the river passes under a double-arched bridge and bends around to the right. In the lee of the central abutment of the bridge deposition of fine sediment has caused a bar to form. This highlights the naturally active morphology of the river and suggests that before it was

constrained by human modifications, the Cale would have been a constantly shifting and changing river and a dynamic habitat.

**Figure 5: A depositional bar has developed in the lee of the central abutment of the double-arched bridge.**

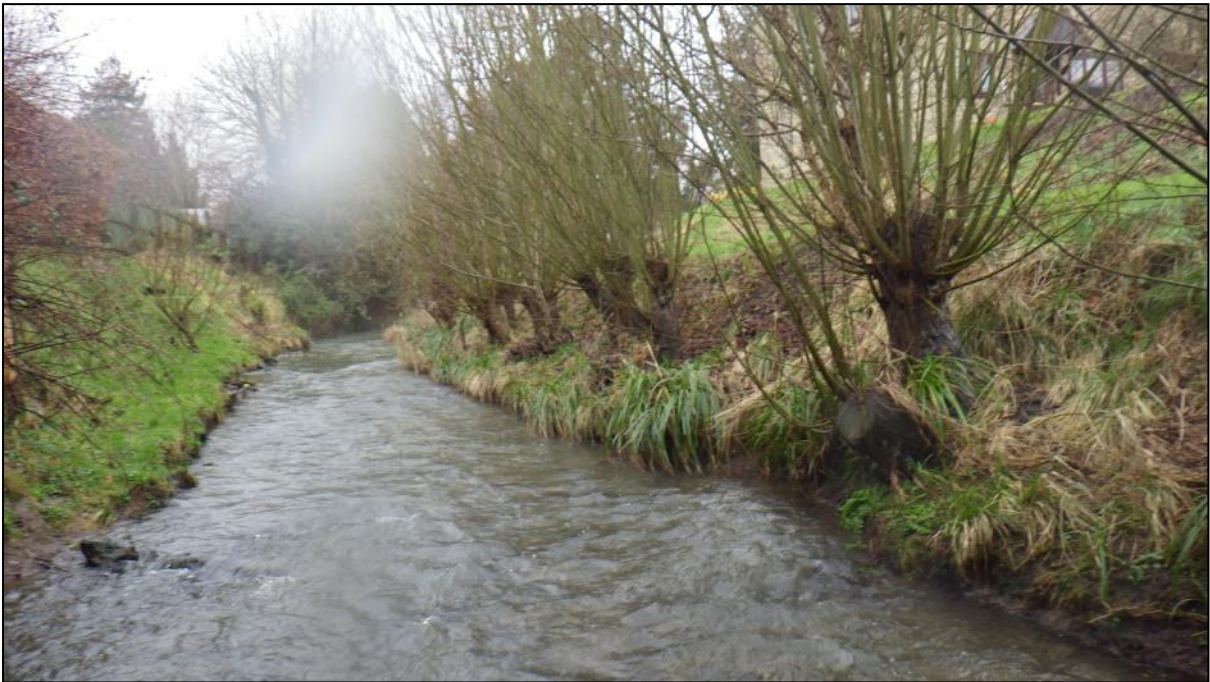
Pollarded willows (*Salix* sp.) are evenly spaced along the left bank. Willow is often planted for bank erosion protection. Provided it is properly maintained to prevent the trees becoming too large and toppling over, the dense root systems help to hold banks together, creating a natural revetment that gets stronger over time.

**Figure 6: Live willows providing bank erosion protection.**

This straightened section could be enhanced by some small, low-lying live willow flow deflectors positioned to kick flows against the right bank where the willows will prevent erosion becoming an issue.

It is worth noting that regular pollarding has caused the willows to grow to a uniform height. The diversity of light conditions in the river would be improved if pollarding were to be undertaken on a rotational basis, allowing a more diverse range of canopy size/shape to develop.

8. Sinuosity could be introduced into the straightened reach upstream of Dead Man's Pool (Fig. 6) by installing some simple flow deflectors or low-level marginal shelves. These can be constructed from brushwood and fixed in place with chestnut stakes. Low-level brushwood shelves can improve habitat whilst having a minimal impact on flood conveyance. They can introduce sinuosity to the channel during low flows whilst being easily over-topped during high flows. They also help to trap fine sediment and can become colonised by marginal plants. If positioned near spawning gravels, brushwood structures can provide important refuge for newly emerged fry.

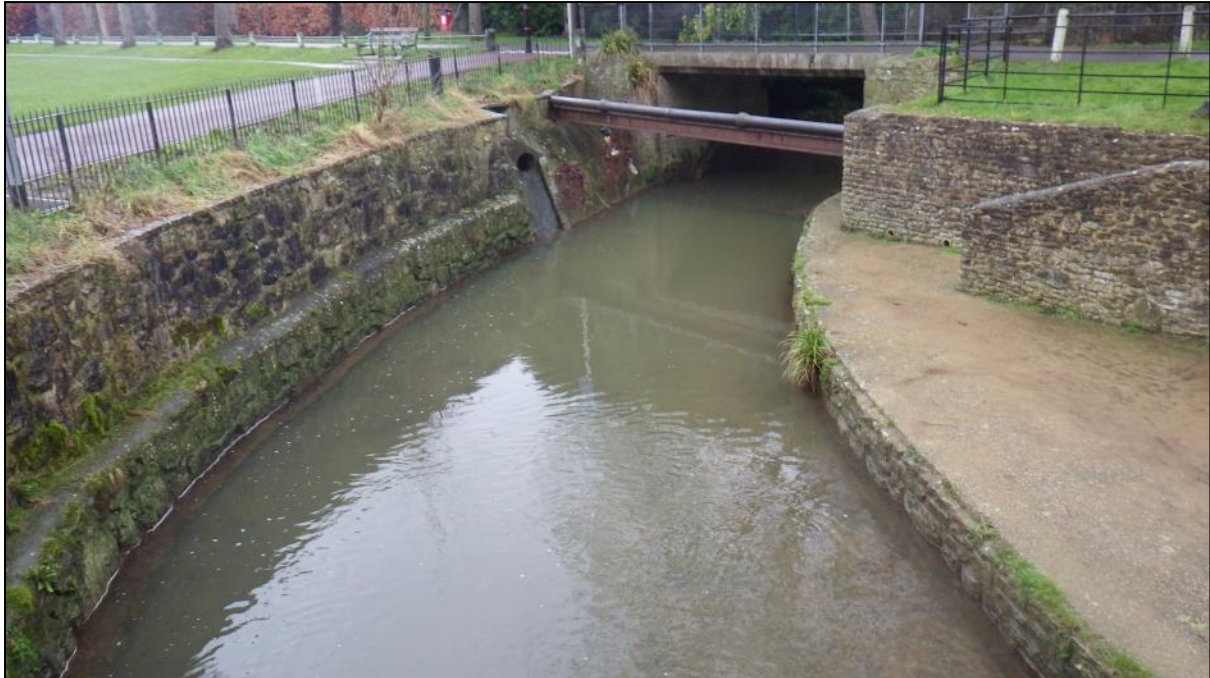
The short section of channel between the bridges is very easily accessible to the public but quite industrial in appearance. A project to soften the appearance of the channel and 'green-up' the bank edge could help to create an attractive

public space where people of all ages can safely access the river. It is important that the river through Wincanton be appreciated as an aesthetically pleasing feature of the town if the amount of litter entering the river is to be reduced. Similar urban projects have benefitted from adopting the philosophy that the more attractive the river looks, the less likely it will be used as a rubbish dump.

**Figure 7: An area with formal access could become a key feature on the river. At present however, the location is quite industrial in appearance and may benefit from being softened with marginal plants.**

The local authority should be engaged to discuss options for improving the aesthetics of this section of channel.

7. The heavily engineered section of channel at the northern edge of the playing fields (Fig 7) could provide an opportunity to create a community access area where local people can safely appreciate the river. There are a variety of companies that specialise in 'greening up' hard engineering and the cost of improving this reach should be assessed against the potential value of an attractive and safe access point for local people and schools.

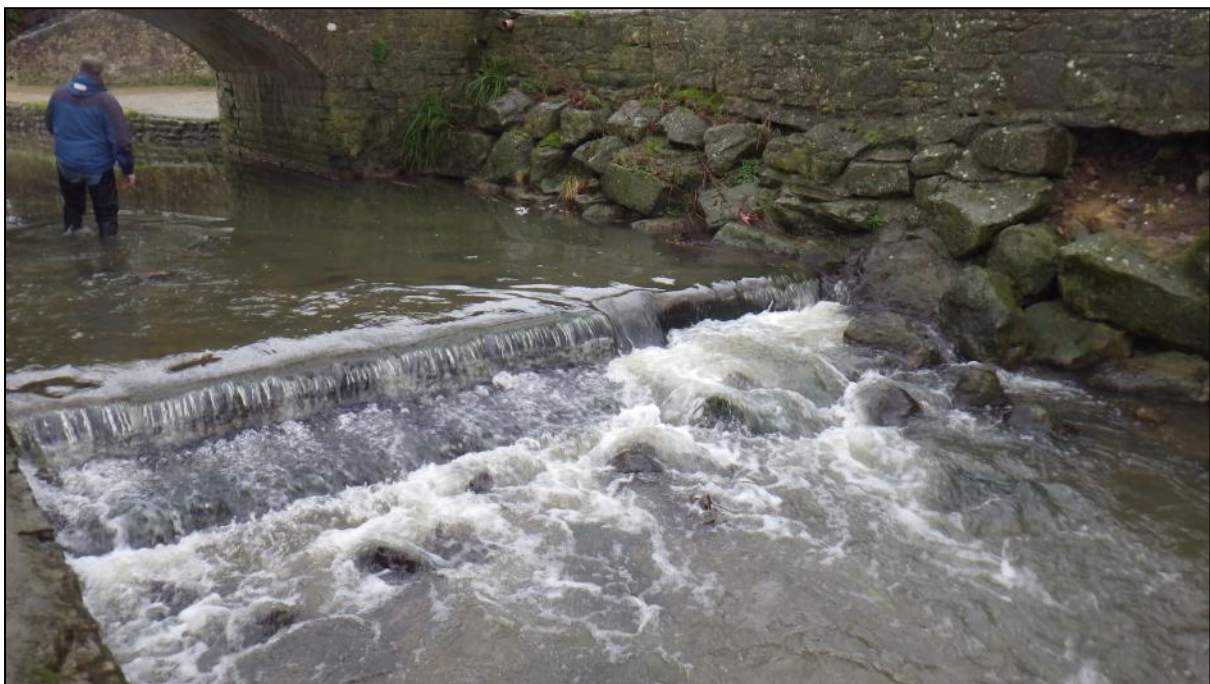
Flows through this engineered section of channel are impounded by a small weir immediately downstream. The impounding effect slows down flow velocity which causes fine sediment to drop out of suspension and uniformly smother the bed, reducing physical diversity the range of habitat available for plants, fish and invertebrates.

Although the impoundment is undesirable in terms of its effect on habitat, the weir acts as a 'pre-barrage' that raises water level over the sills of the bridges and ensures they are passable to fish. Considering the impounding effect is drowned out a relatively short distance upstream and that the weir itself is passable to fish, it may be best to leave the weir in place for the short term. The weir is passable to fish because of a notch in the crest that allows a solid plume

of water to flow through and guide fish up through the obstacle. Passability could be improved further by rearranging the large boulders downstream of the notch to minimise turbulence and reduce the amount of entrained air (white water) which can create hostile conditions for fish.

**Figure 8: A small weir impounds the river but is passable for fish and acts as a pre-barrage to the sills of the bridges upstream**

At Reavensbury Park on the River Wandle in London, The Wandle Trust recently replaced a similar sized weir with a retained gravel riffle which has improved fish passage and also introduced potential spawning habitat. A similar project could be a good medium term goal for this weir.

Works to green-up this area could be made more cost effective and valuable if undertaken in combination with works to replace the nearby weir (Fig 8) with a retained gravel riffle.

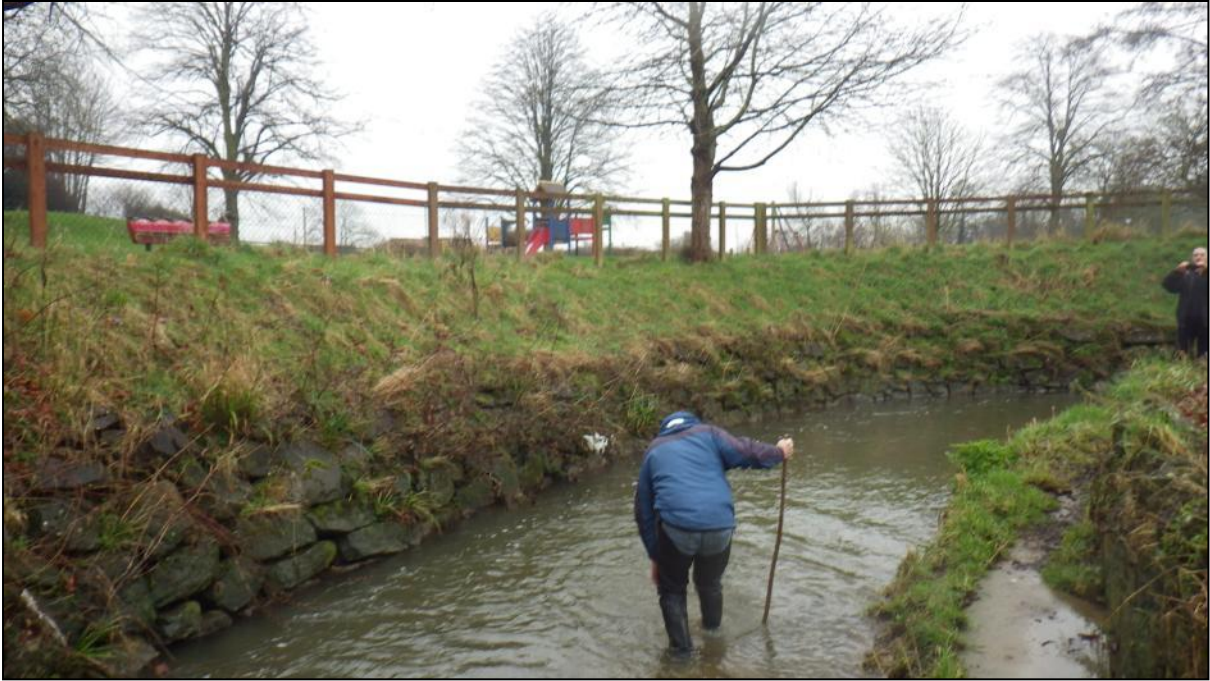
After the weir, the Cale is pushed in a weeping bend to the right by a 'rip-rap' revetment on the left bank. This revetment may have been installed to protect the railway from the river. The gaps in the rocky revetment actually provide some good habitat niches in which invertebrates and small fish can shelter. Additionally, sedges (*Carex* sp.) have colonised some of the gaps in the revetment. Additional planting of sedges in the revetment could introduce more marginal cover for fish and provide an important interface between the terrestrial and aquatic habitats. Many freshwater invertebrates have life stages both in and out of the water and marginal plants are important for fly life such as damselflies and mayflies which use marginal vegetation to rest on whilst they prepare for flight.

**Figure 9: Although not ideal, the rocky rip-rap revetment on the left bank does provide some habitat for invertebrates and plants**

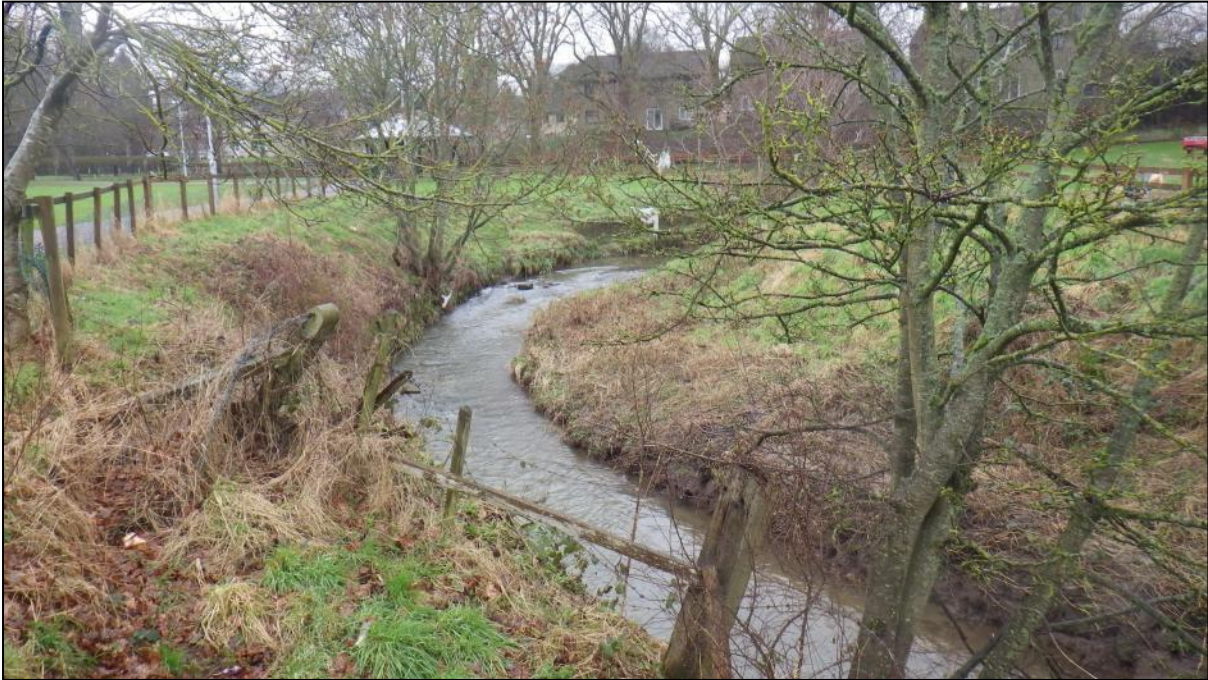
As the river flows alongside the playing fields it begins to resume a more natural course and becomes noticeably more sinuous. Low-lying shrubby bankside plants provide some good overhead cover for fish and the roots of bankside trees help to introduce diversity by deflecting flows and also provide coarse woody debris which can be an important refuge for juvenile fish. Large pieces of rubble introduce further flow variation and create pockets of localised bed scour.

Scour on the bed in shallow, faster-flowing sections of the river is particularly important for the River Cale. As the headwaters are cut-off from the river downstream, the naturally shallowest sections of river with the steepest gradient are not accessible to trout or other gravel spawning species such as dace (*Leuciscus leuciscus*). As a result, spawning opportunities are limited to sections of fast flowing river in which rubble or large woody debris (LWD) cause scouring of the bed which in turn lifts and naturally sorts the gravel substrate. Trout in particular need un-compacted, well oxygenated, clean gravel in which to cut their nests known as 'redds' and lay their eggs. The eggs must remain well-oxygenated in order to survive.

**Figure 10: Habitat quality is improved as the river becomes more sinuous and faster-flowing**

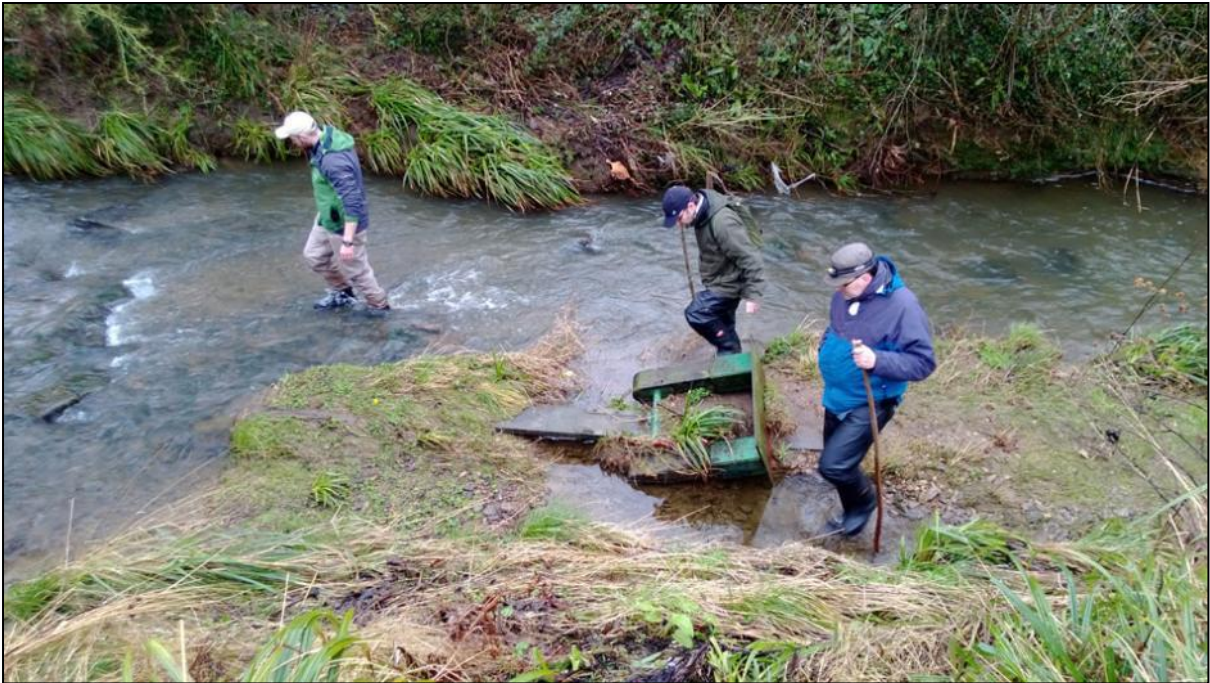
Downstream of the playing fields as the river bisects the green space between Wincanton Business Park and The Tythings Commercial Centre, is a short section of richly diverse habitat. Shallow, fast-flowing riffles and deep scour pools with overhead cover from tree roots provide good quality habitat for flow loving fish. A sandy berm has developed into a marginal shelf which has become colonised by marginal plants. This section of river could become a model for creating good quality spawning and nursery habitat for trout and with some tweaks could become a template for future works.

**Figure 11: The fast-flowing and diverse habitat downstream of the playing fields**

2. A small project to further enhance the fast-flowing and diverse section of river downstream of the playing fields (Fig 11) by the installation of some simple habitat features could be a good platform from which to launch further projects. Creating a small section of ideal habitat where the public can clearly observe the stark contrast of the impounded reach downstream could help to galvanise local support for the restoration of the river. Making relatively small habitat tweaks around the existing natural processes occurring at this location will also aid the understanding of volunteers and help to guide the development of other habitat enhancements.

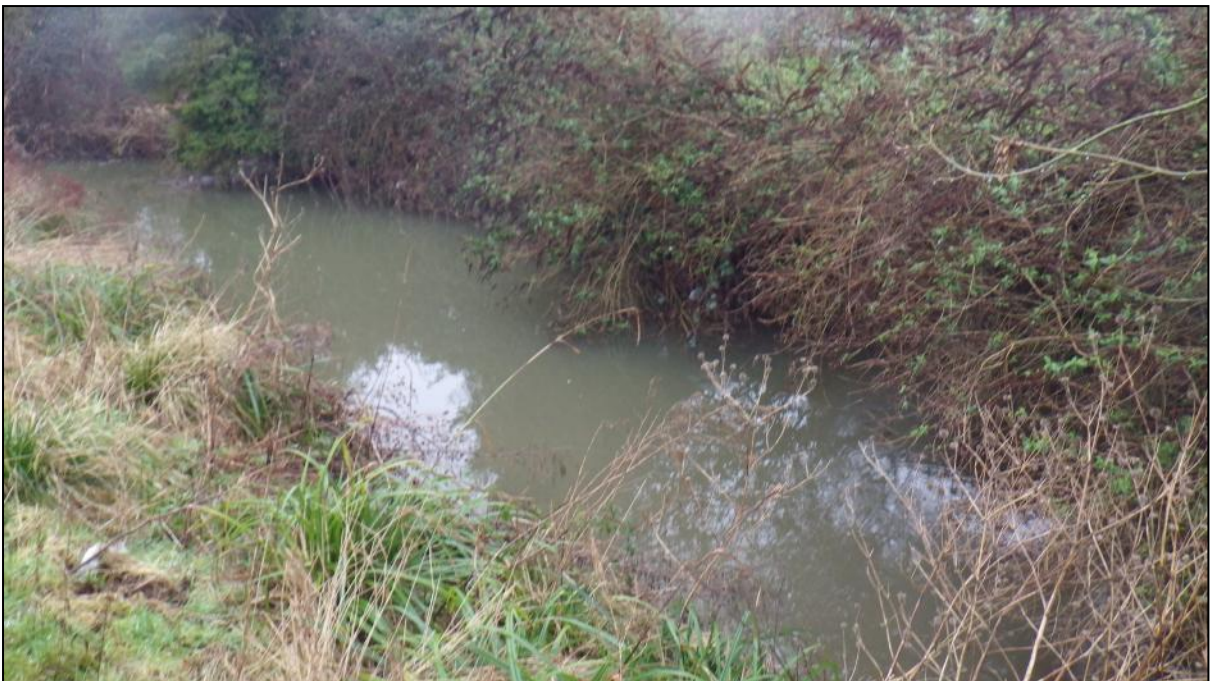
Unfortunately, habitat diversity reduces only a short distance downstream as the impounding effect of a weir below Hawkers Bridge (ST 70981 28023) artificially deepens the river. The river continues to follow a naturally meandering course but it becomes sluggish and flows become uniformly laminar.

**Figure 12: The habitat diversity of the meandering channel is significantly reduced as the flows are impounded by the Hawkers Bridge weir which slows flows and significantly reduces in-stream morphology**

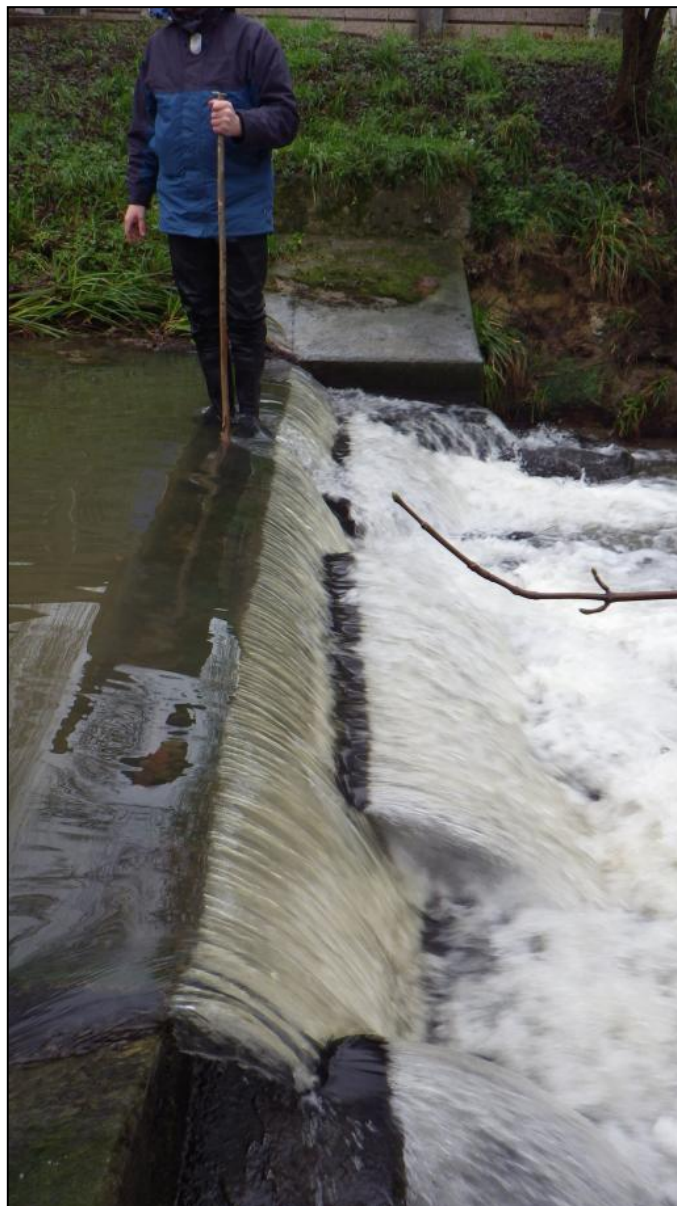
The weir appears to have been installed to hold up a head of water, probably to abstract for use in a large dairy products factory. The factory was central to the economy of Wincanton for nearly a century and the exploitation of the river would have been key to its operation. The structure is a significant barrier to fish passage, likely only to be passable during high flows.

**Figure 13: The weir below Hawkers Bridge**

Within the weir, two sluices are probably remnants of a control structure. Removing these sluices could be a stopgap to weir removal. However, this should only be undertaken with the permission of the owner of the weir and with the consent of the Environment Agency. A trial may be required to gauge the response of the river. If the water flowing through the sluices is too turbulent, the weir may not be rendered any more passable to fish than it is at present.

The structure now appears to be redundant and removing it or lowering a significant proportion of it to bed level could dramatically improve the habitat upstream and improve habitat connectivity, allowing more fish up into the recreational areas of the town. Removal of the impoundment could also reduce flood risk.

If weir removal or lowering is deemed infeasible, it may be worth considering the option of installing a pre-barrage onto the weir apron downstream to reduce the head loss over the weir and potentially reduce the turbulence of the water flowing through the sluices. A notch could also be cut into the crest of the weir to help ease fish passage.

6. The weir below Hawkers Bridge should be removed or lowered to bed level. This may have a significant associated cost and may require specialist contractors. The option of opening the sluices in the weir as a stopgap measure should be discussed with the owner of the weir and the Environment Agency.

If the sluices are to be raised, it is strongly recommended that an initial trial be undertaken with the greatest care to ensure that the sluice can be lowered again.

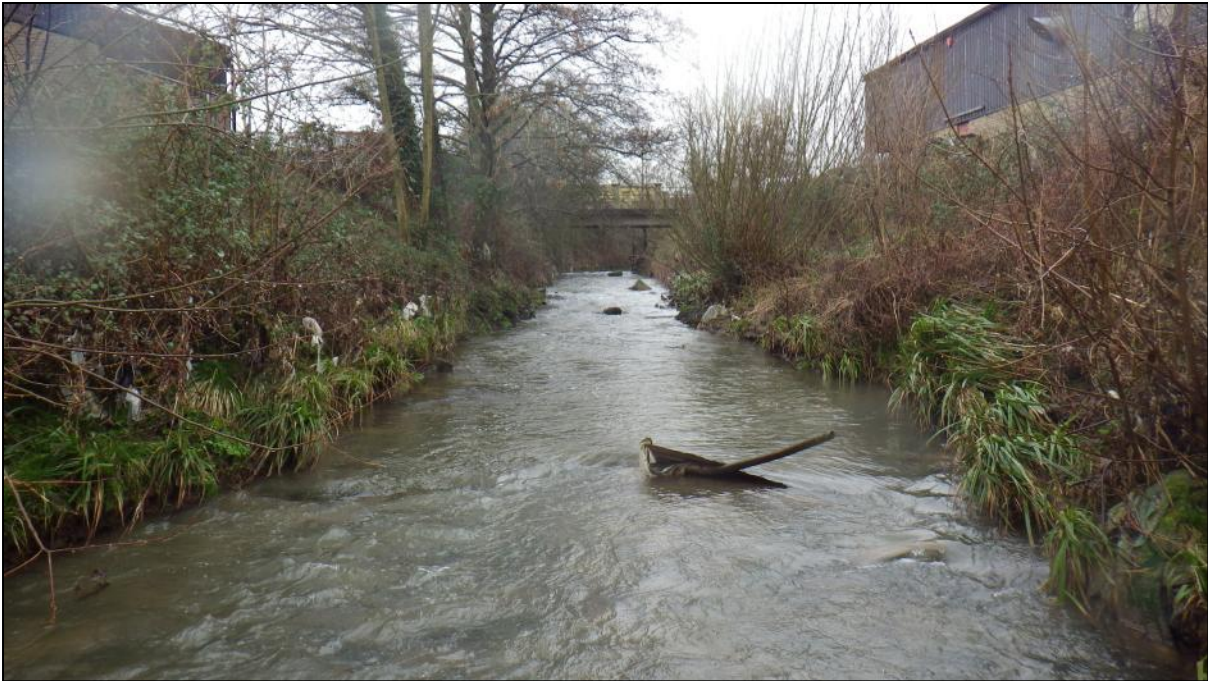
Downstream of Hawkers Bridge, the river flows alongside Bennets Field Trading Estate. The river here is heavily incised and the banks are very steep. This has reduced the width of the true marginal zone before the river bank becomes a terrestrial habitat. However, a community of sedges has established along the water's edge and the inaccessibility of the river has ensured that the river is relatively undisturbed. The bed is strewn with rubble which could be relatively easily repositioned to focus scour into deeper pools and introduce greater flow diversity. Some simple log flow deflectors could also be fixed to the bed.

With some relatively simple tweaks, habitat diversity could be increased alongside the industrial estate and downstream to the A303 bridge. However, a major factor through this reach is the volume of litter both in the channel and along the banks. Poor fencing of the top of bank means that industrial debris can easily disperse and roll into the river.

**Figure 14: The river downstream of Bennets Field Industrial Estate could be cost-effectively improved by the installation of some simple flow deflectors and the repositioning of existing bed load.**

A campaign to raise awareness and improve fencing and waste management through the industrial estate would help to reduce the volume of litter in the river and could help to improve water quality.

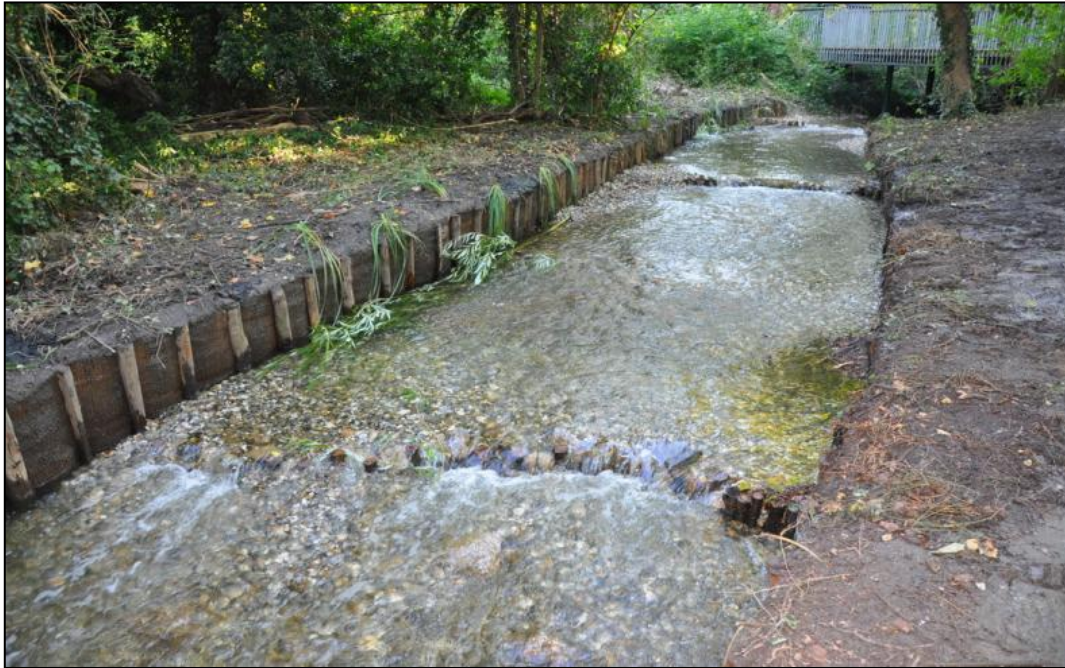
**Figure 15: A long gravel installed to replace a weir in Ravensbury Park on the River Wandle. Image courtesy of Cain Bio-Engineering Ltd.**
